## Matthew Jones House

Historic Maintenance and Repair Manual

### **Final report**

Under   Project # 396574, "Matthew Jones House Maintenance & Repair Manual."

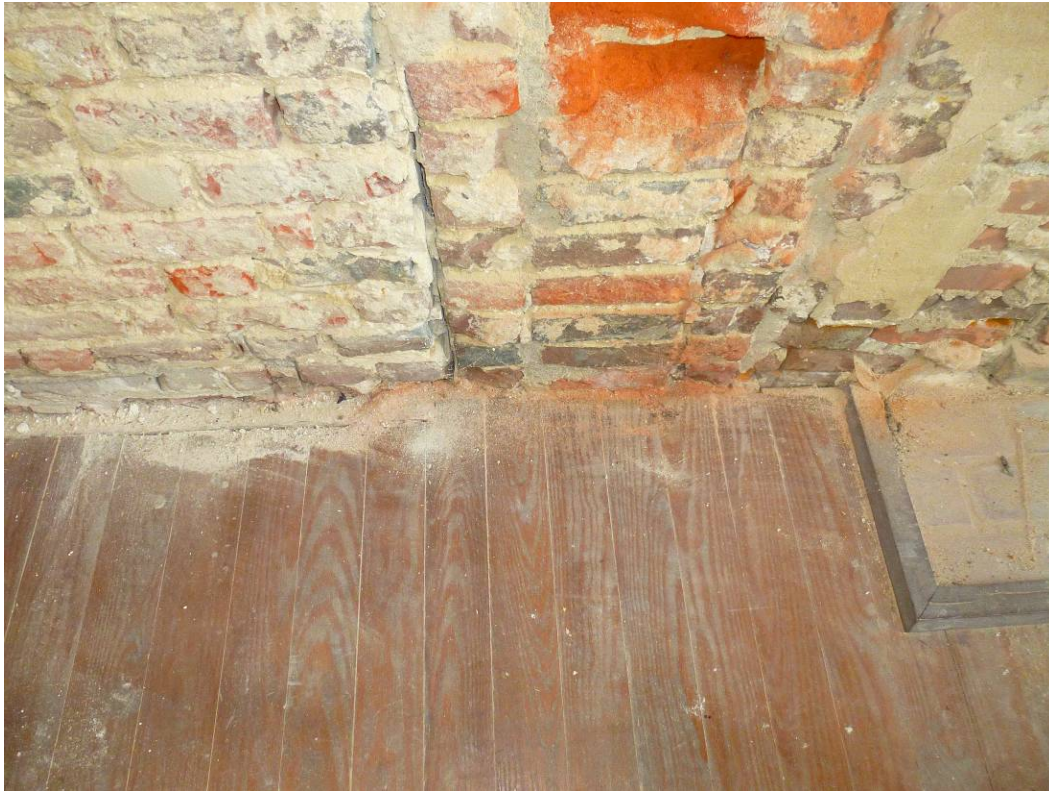
moisture and condensation within the bricks. The bricks are ultimately crumbling to pieces. Evidence of this is seen on the interior with the buildup of “brick dust” at the base of each wall (Figure 88).

Figure 88. Interior of brick wall showing the “brick dust” (ERDC-CERL, 2012).

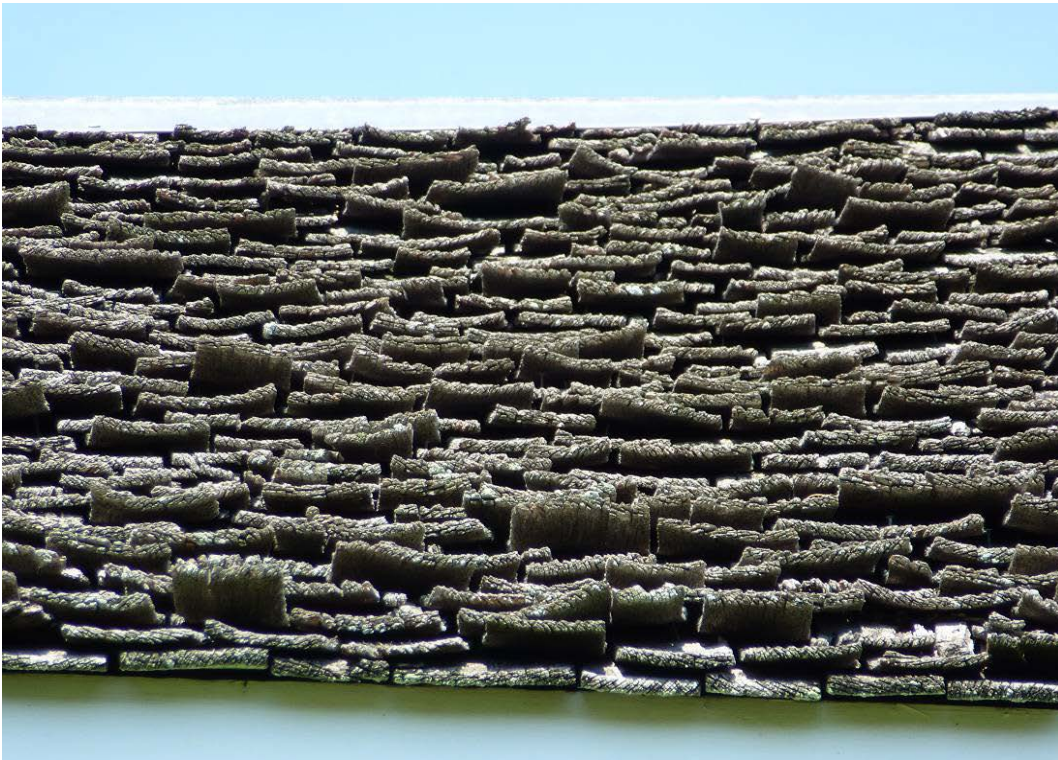
Figure 89. Cupping of the wood shingles, uniformly across entire roof (ERDC-CERL, 2012).

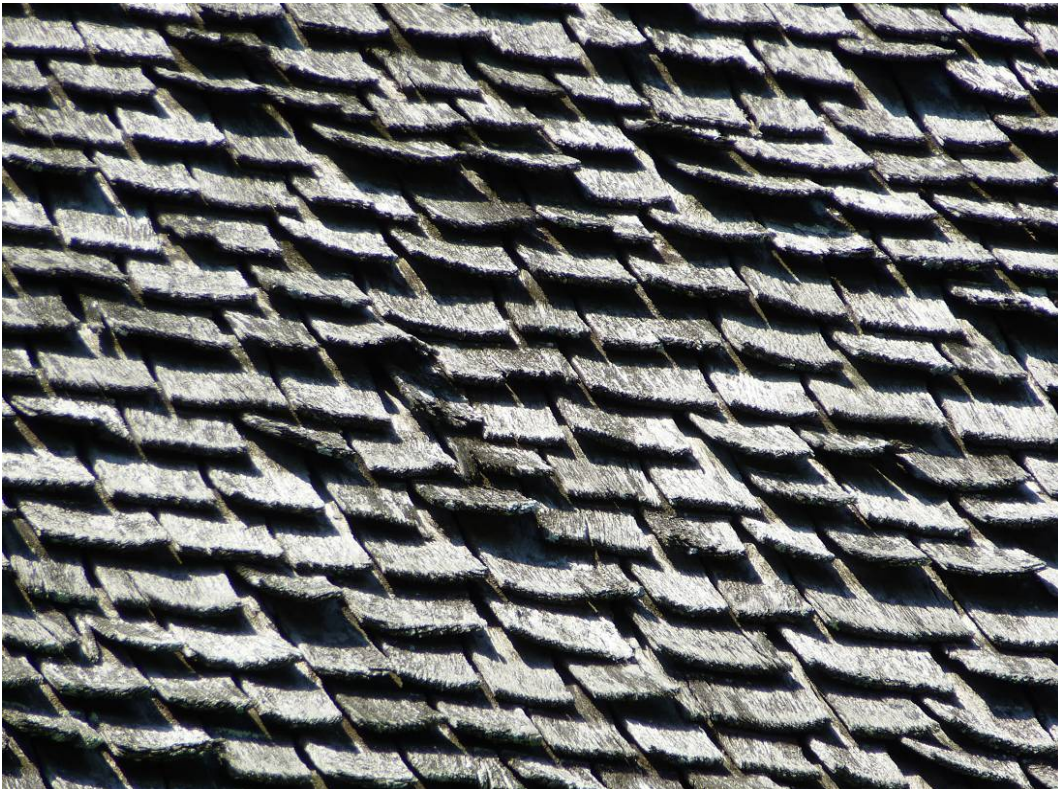
Figure 90. Weathered wood shingles, uniformly across entire roof (ERDC-CERL, 2012).

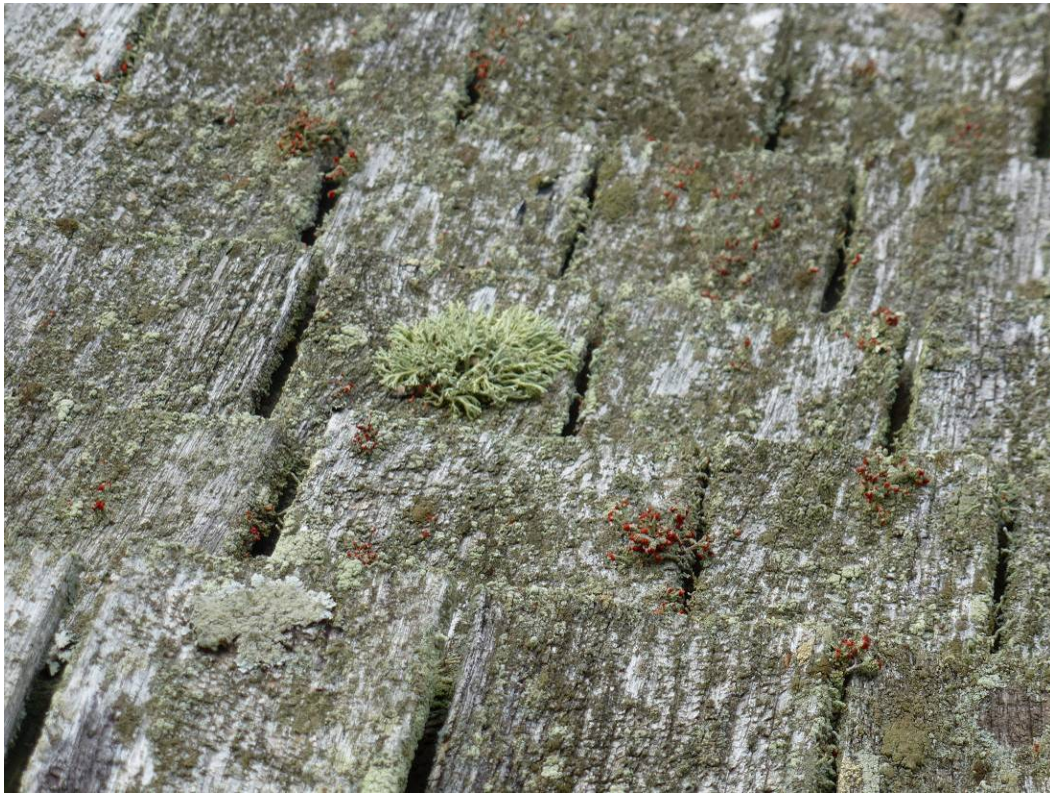
Figure 91. Mold and lichen growth on wood shingles (ERDC-CERL, 2012).

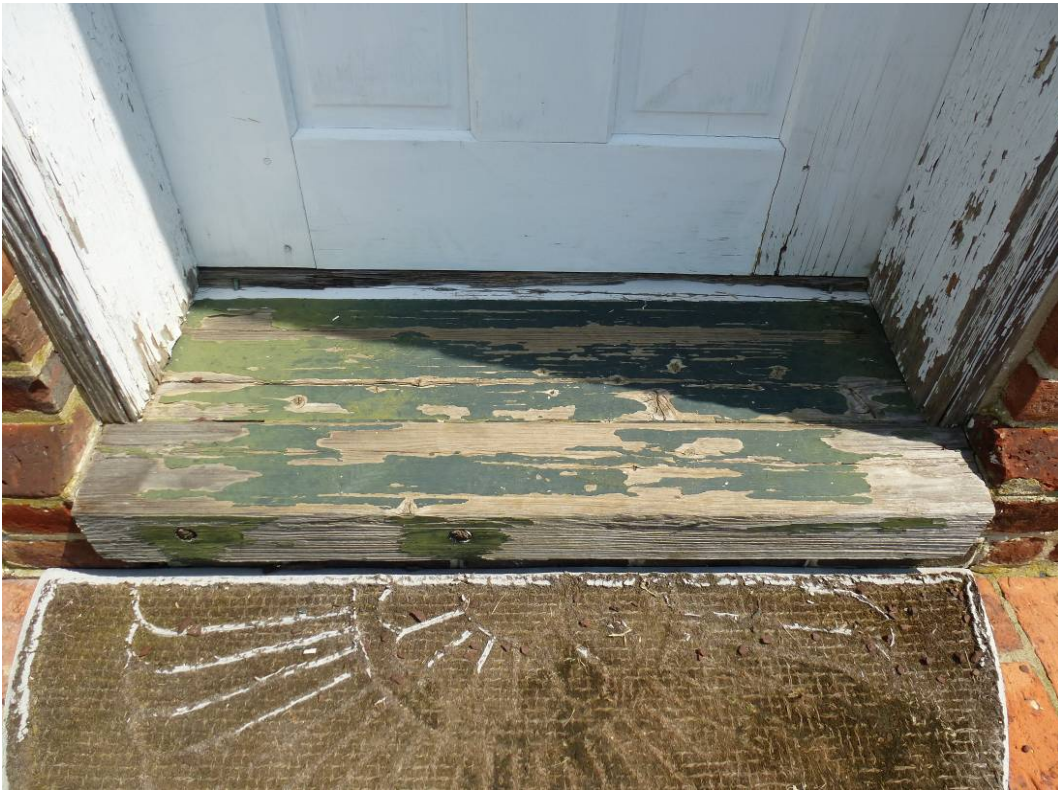
Figure 102. Wood threshold for the main door with chipped paint (ERDC-CERL, 2012).

- the door on the southeast elevation needs to be removed and replaced with a historically sensitive door (Figure 104 and Figure 108), and
- the wood frame around each door needs to be repainted (Figure 103), and
- the threshold for the main door on the southwest elevation needs to be repainted (Figure 102), and
- the threshold for the side door on the southeast elevation is too deteriorated to rehabilitate and needs to be removed and replaced with in-kind materials (Figure 105), and

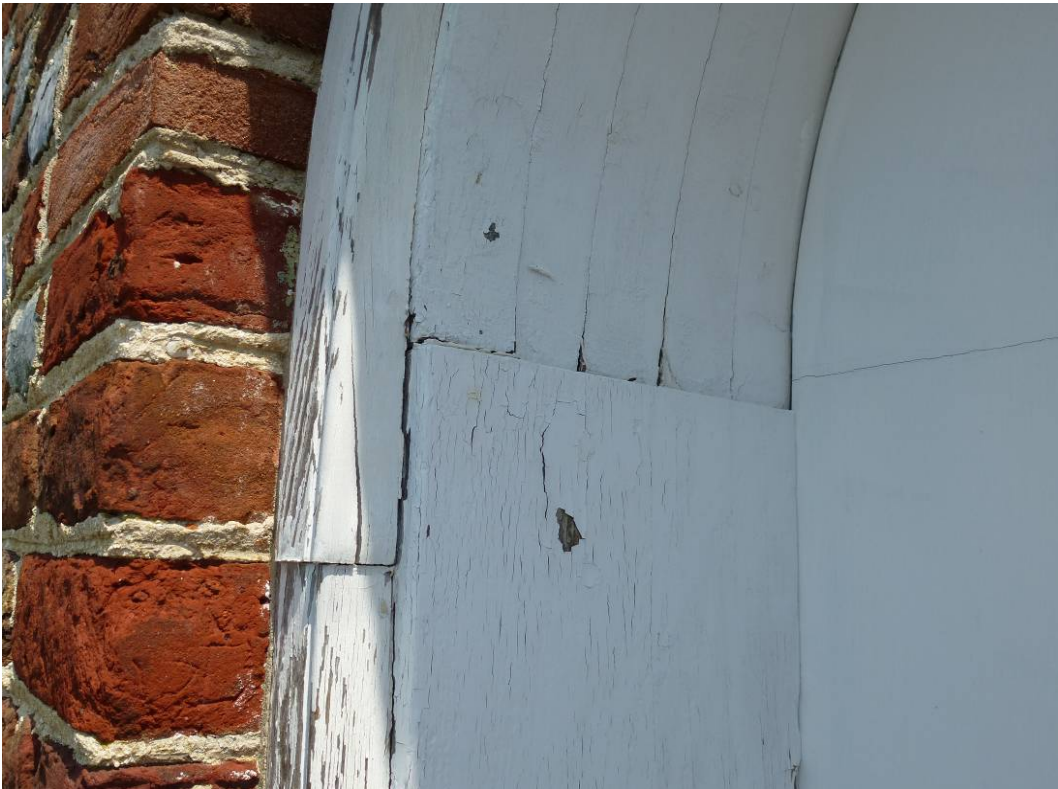
Figure 103. Glued arched jamb of the front door (ERDC-CERL, 2012).

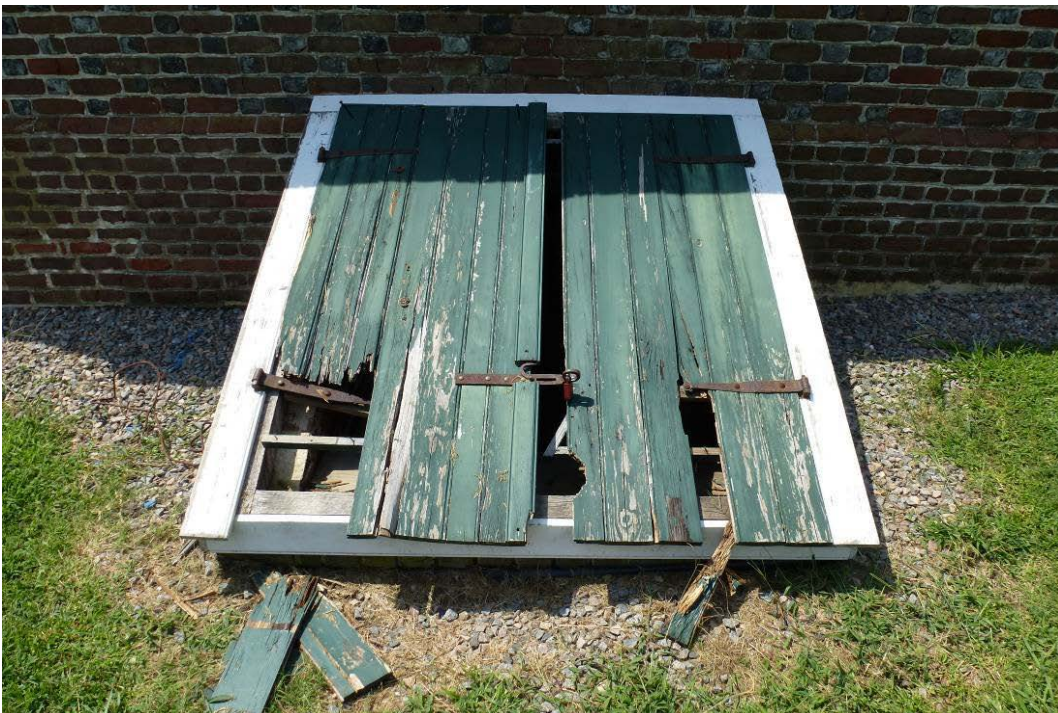
It is unknown what the original configuration of the entrance into the cellar was; it appears now to be different from the historic photograph (Figure 5). Currently, access to the cellar is through a modern bulkhead on the center of the rear of the shed. The present door opening aligns with that in the interior brick partition wall, with two wood slat doors attached with metal strap hinges. At the time of the initial site visit in 2012 to the Matthew Jones House, the two cellar doors were badly deteriorated (Figure 106), but they have since been replaced.

Figure 106. Damaged wood cellar doors have been replaced since this photograph was taken (ERDC-CERL, 2012).

Since the time of the initial site visit to the Matthew Jones House, the staff in the CRM Office at Joint Base Langley-Eustis have removed and replaced the deteriorated and damaged wood cellar doors in-kind with new wood cellar doors (Figure 109). A note to keep in mind is that a house of this era did not have any type of gutter systems; therefore, the wood hatch doors into the basement will always be susceptible to water damage, especially since these doors take on rainwater from both slopes of the house roof and also from the shed roof of the appendage located on the rear of the building. Joint Base Langley-Eustis will either have to budget money to continually repair cellar doors or install a drainage system to divert water away from the structure. Either action will require SHPO concurrence.

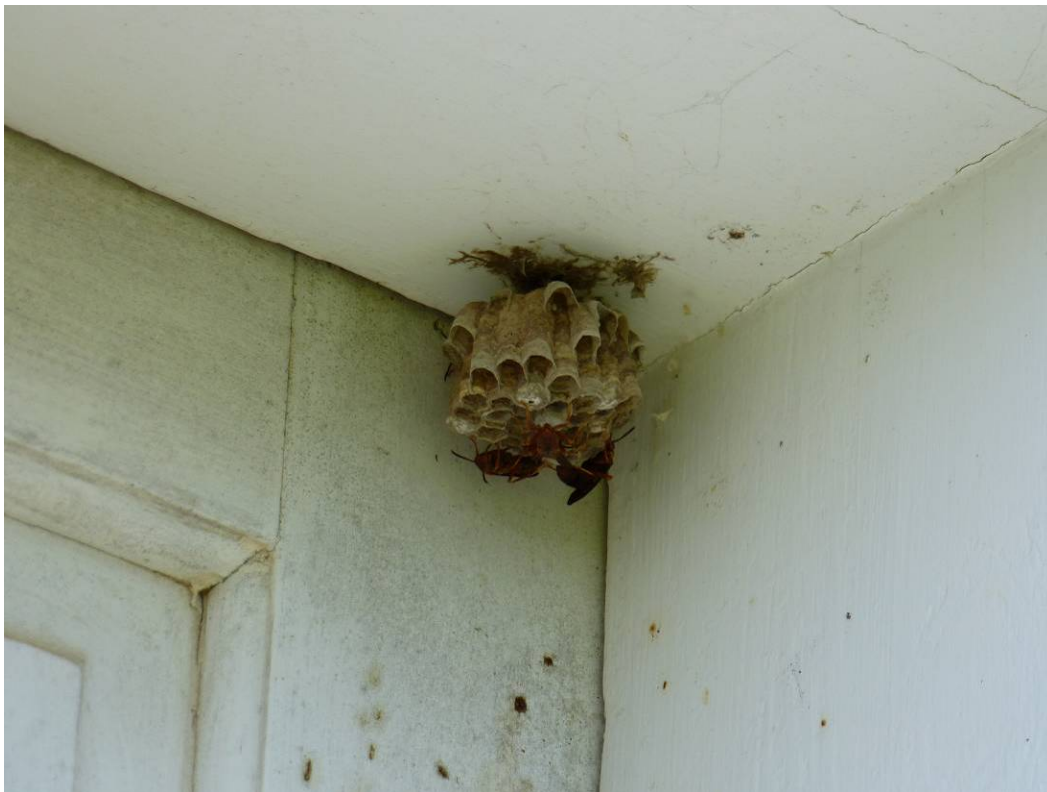
Figure 107. The insect growth/nests should be removed from all wood members (ERDC-CERL, 2012).

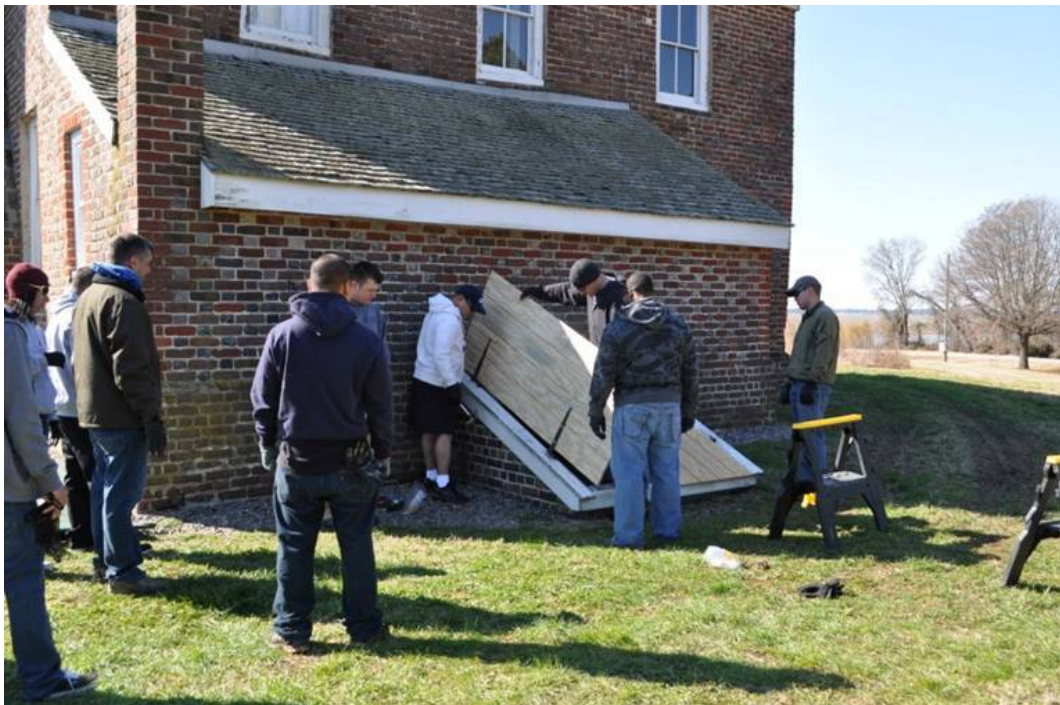
Figure 109. Along with Fort Eustis CRM staff, soldiers volunteered time to replace the cellar doors (Fort Eustis Cultural Resources, 2013).

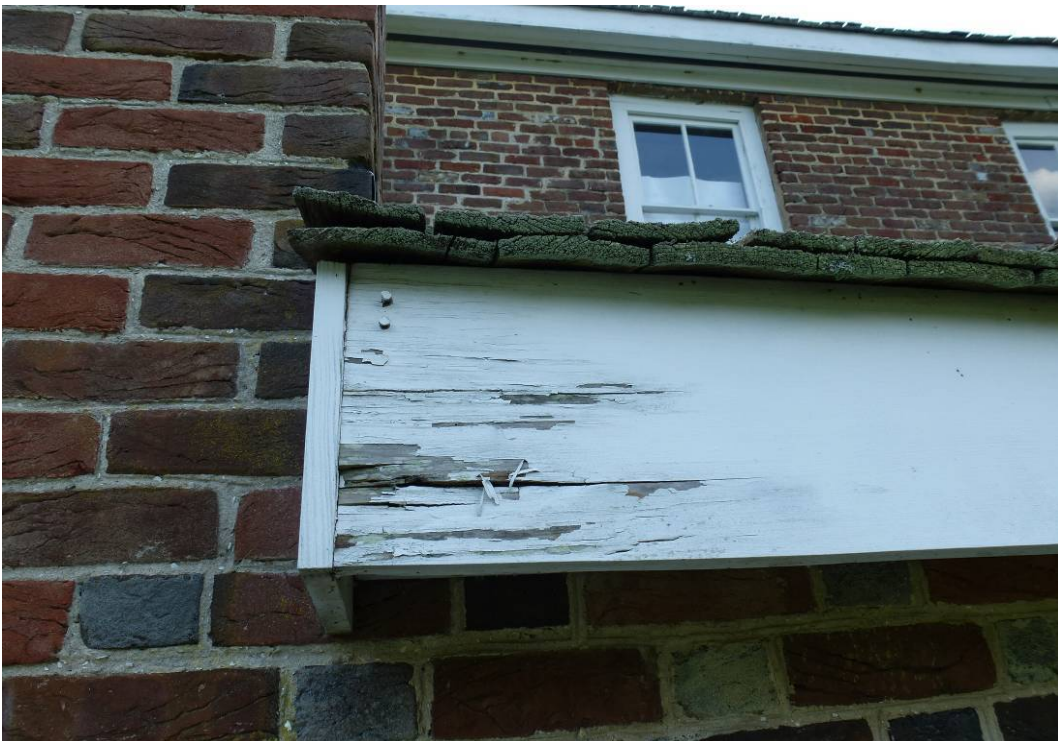
Rakeboard is a board fastened to the projecting gables of a roof to give them strength and to hide and protect the otherwise exposed end of the horizontal timbers. The gables of the Matthew Jones House are decorated with rakeboard designed in a simplistic manner. The wood rakeboard, fascia, and soffit are painted white (Figure 120 and Figure 121). Some areas of rakeboard show evidence of damage (Figure 122–Figure 123) or problems such as insect nest formation (Figure 125).

Figure 123. Damaged rakeboard on the northeast side of the shed room (rear chamber) (ERDC-CERL, 2012).

Any exposed end grain of wood members should not be left untreated. End-grain wood is the wood that shows the growth of rings of the tree. This area has a tendency to absorb paint, so it must be primed prior to painting; if it is not primed, the porous wood grain will soak up the paint and alter the paint color. End-grain wood is commonly found at the ends of boards, but is also found in the wood knots of boards. Unfinished wood grain is rough and needs to be sanded before paint or primer is applied. Painting the wood end grains ensures that the wood is sealed to prevent any future deterioration or decay. The wood rakeboard located on the shed room (rear chamber) addition is in need of immediate attention and repair (Figure 122 and Figure 123).

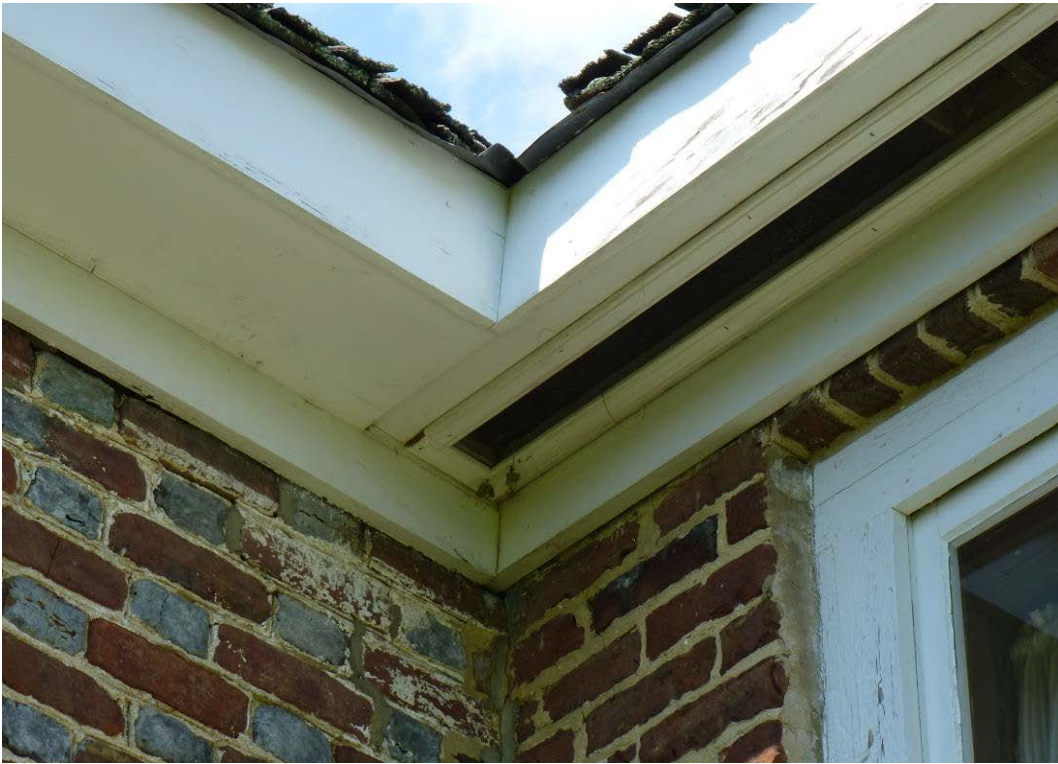
During the 1993 preservation work, narrow slit vents were added to the soffit to allow more ventilation within the house (Figure 124). However, due to the issues of moisture that the air conditioning system is causing, these vents might either be hindering the preservation of the wood shingles or are not adequate enough to preserve the wood shingles.

Figure 124. Underside of the wood soffit where vents have been cut in to provide attic ventilation (ERDC-CERL, 2012).

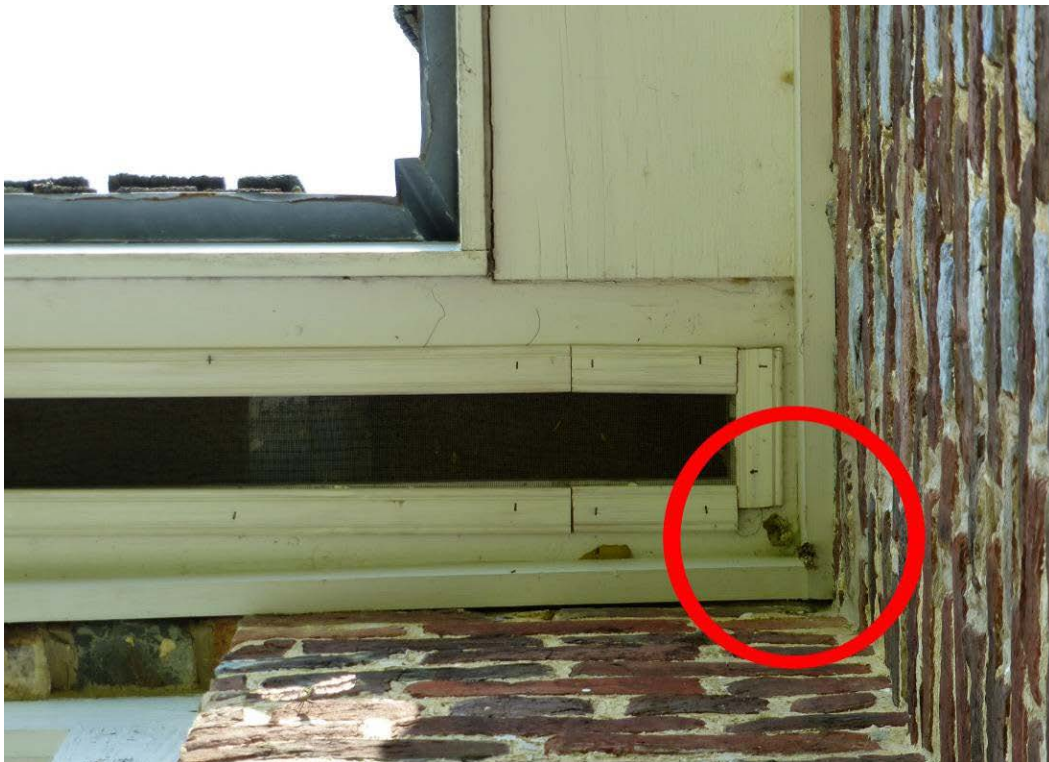
Figure 125. Several areas under the wood soffit where insect nests have formed. Here, one area is circled in red. All should be removed (ERDC-CERL, 2012).

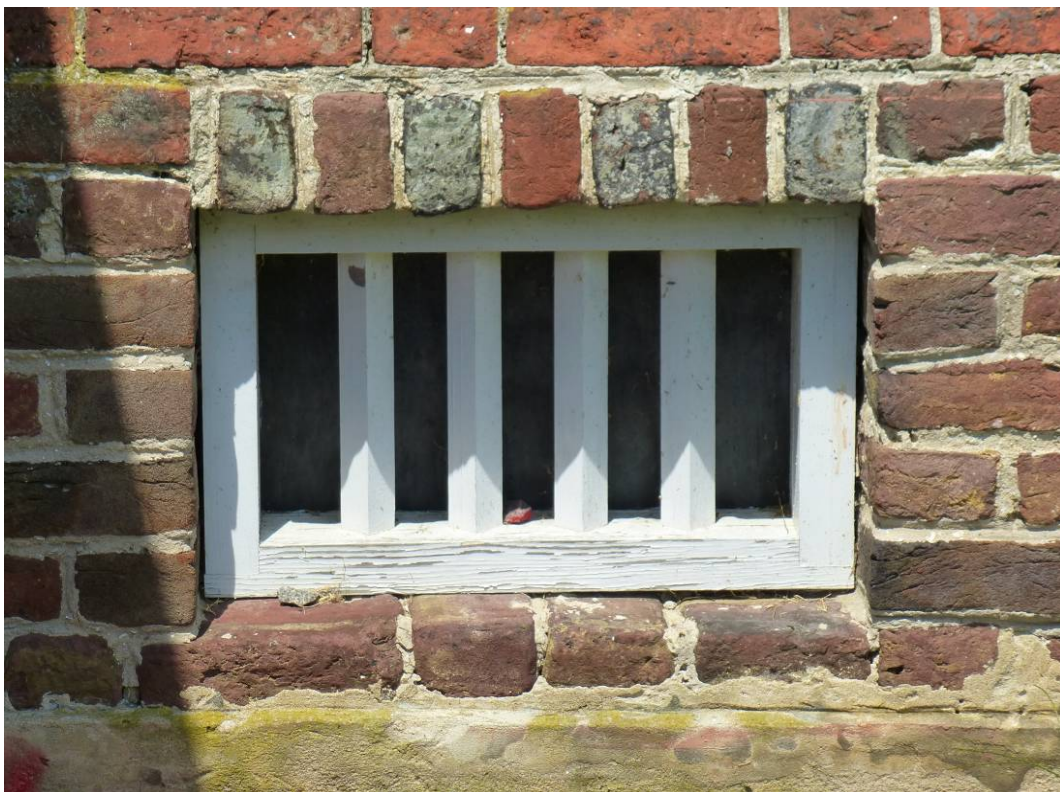
Figure 126. Wood-louvered vent on the southeast elevation that is blocked from the basement side (ERDC-CERL, 2012).

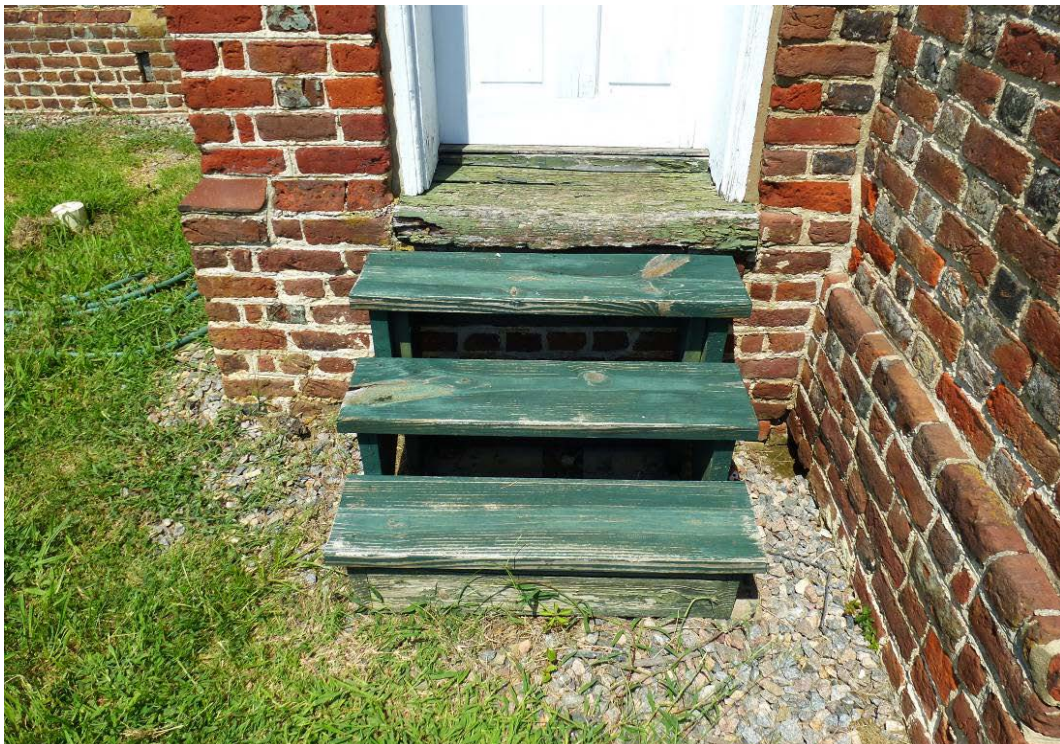
Figure 128. Wood steps on the southeast elevation should be addressed for safety concerns (ERDC-CERL, 2012).

The wood steps that provide access to the side door on the southeast elevation should be addressed for safety concerns (Figure 128). A set of new steps need to be built to code for safety purposes, including a handrail, especially if this door will be used by visitors.

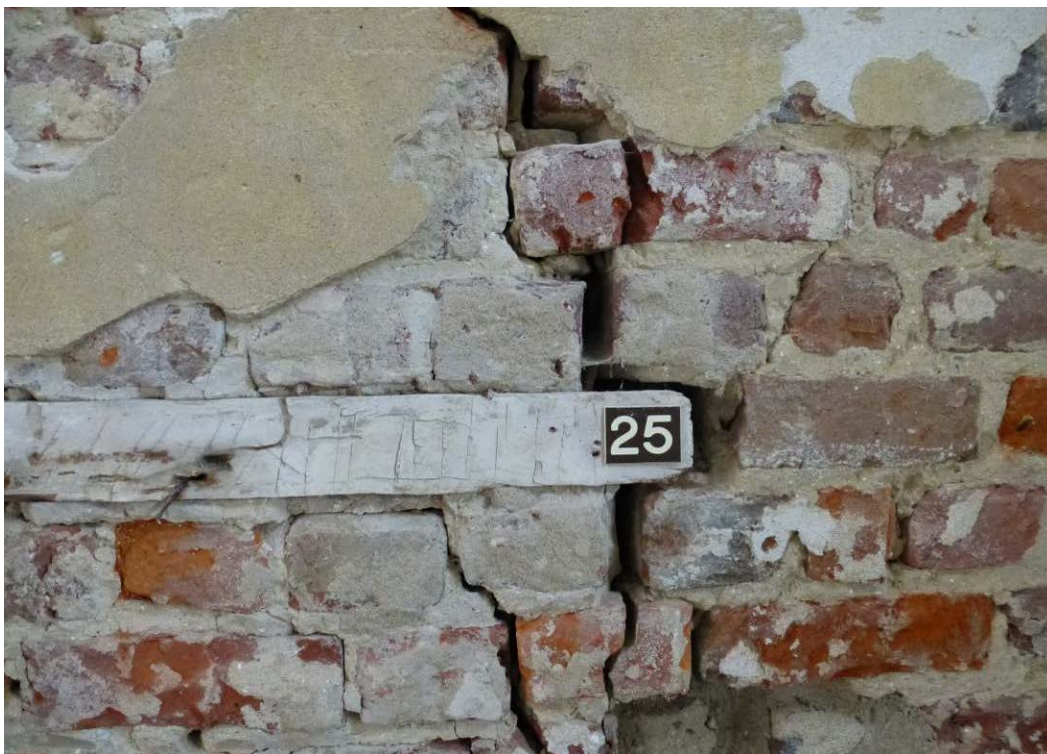
Figure 136. Large crack in brickwork around hall fireplace (ERDC-CERL, 2012).

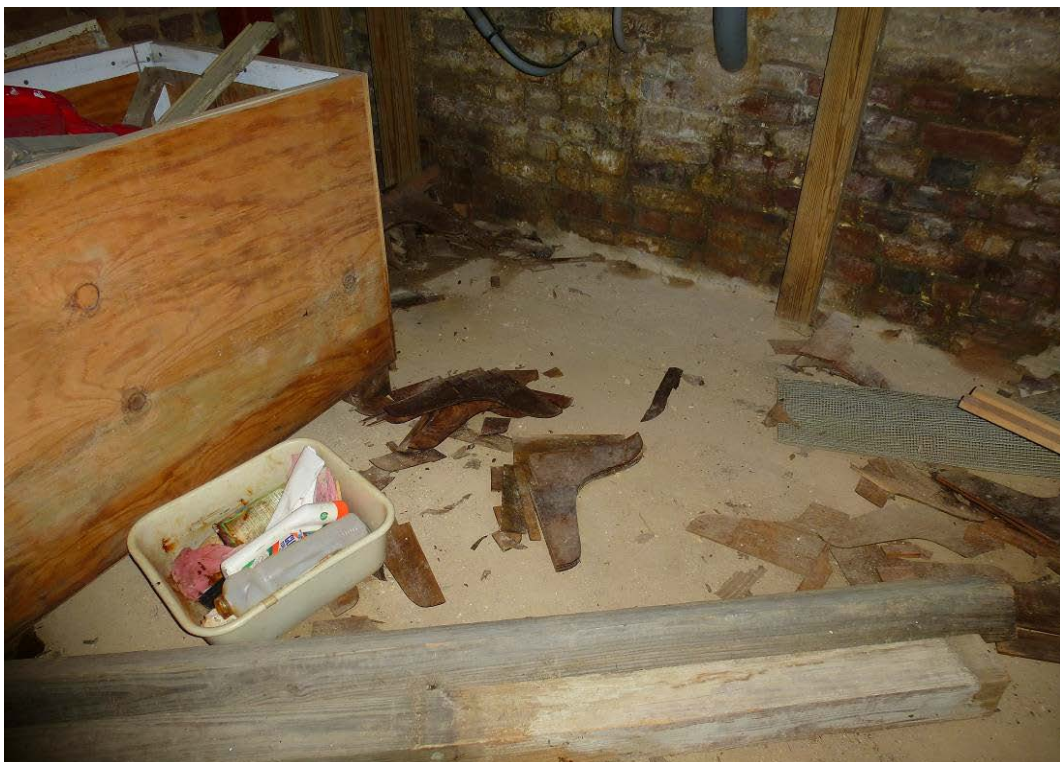
Figure 146. Wet bricks in cellar caused by standing water on cellar floor (ERDC-CERL, 2012).

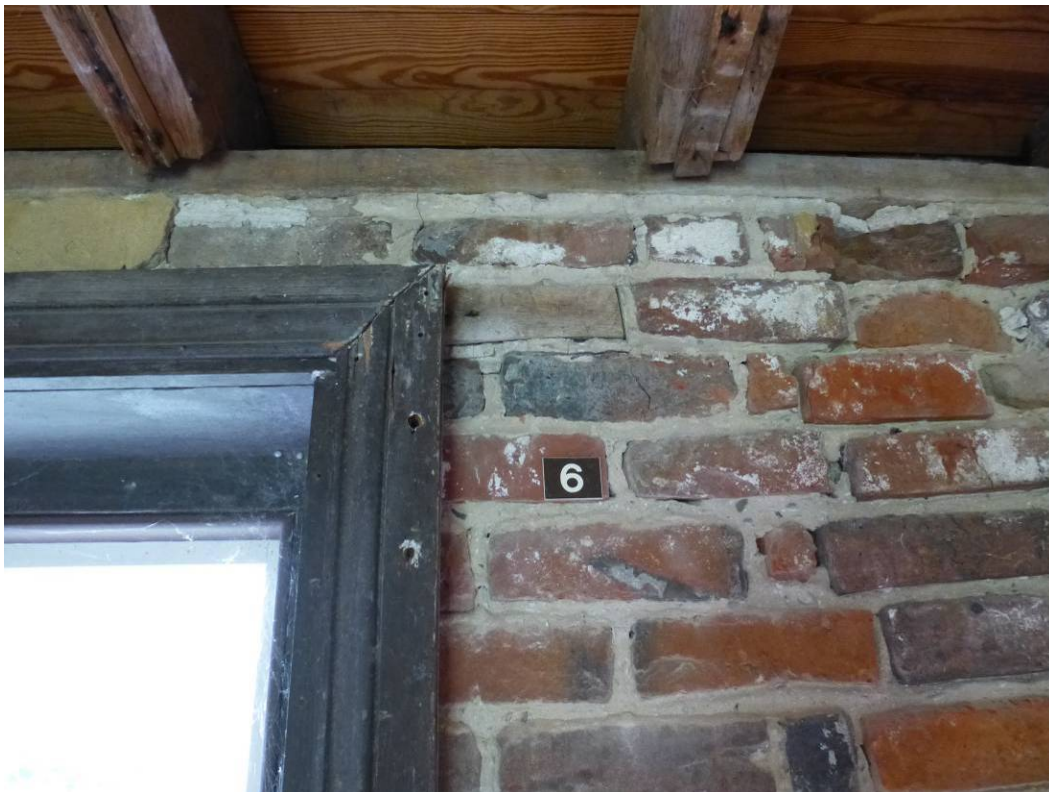
Figure 148. Northeast brick wall of porch tower with failing plaster work (ERDC-CERL, 2012).

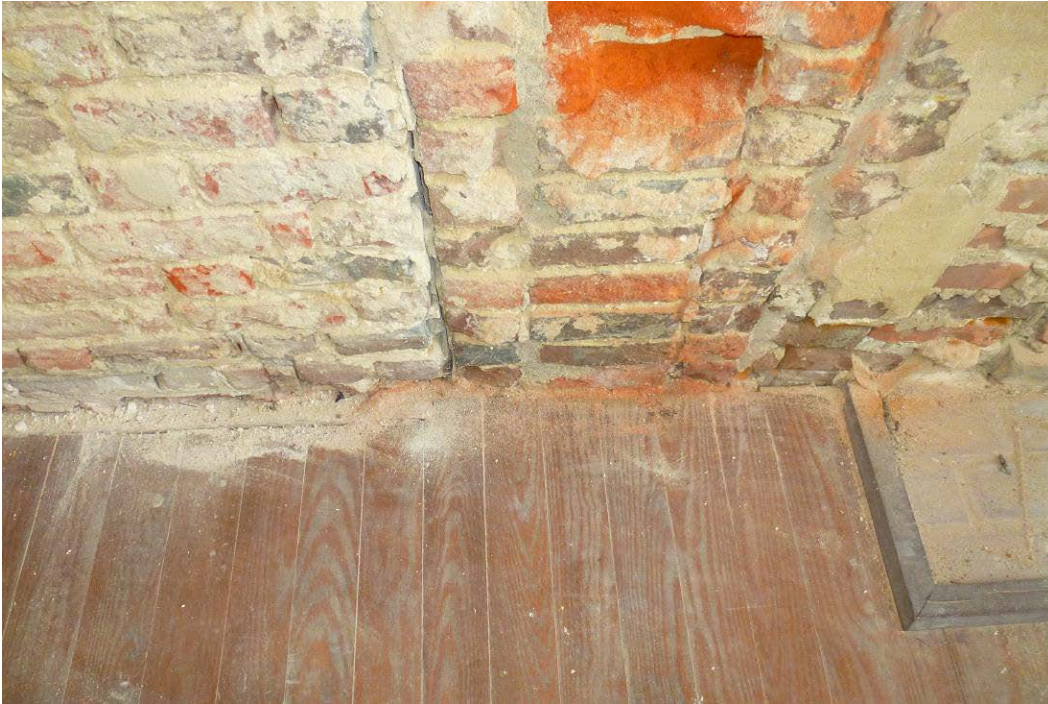
Figure 150. Holes in the brickwork around the perimeter of the hall were for chair board blocking ; when the frame walls were replaced with brick ca. 1730, wood blocks were installed to carry a chair board (ERDC-CERL, 2012).

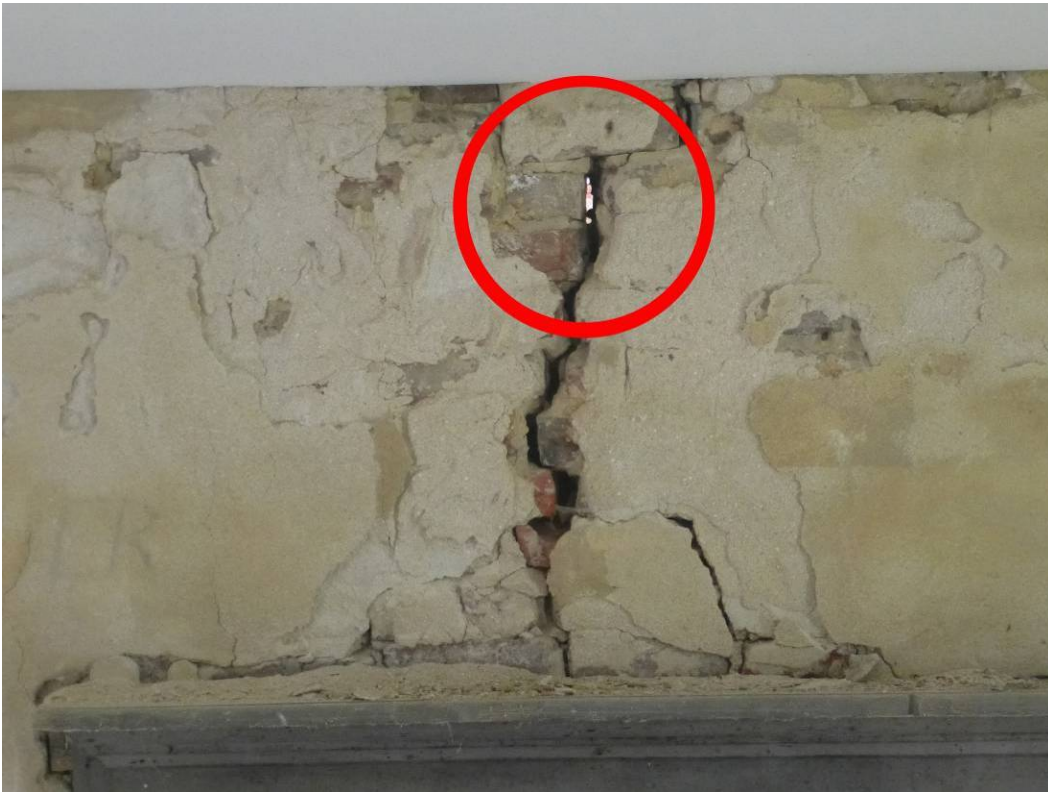
Figure 152. Close-up of the structural crack above the fireplace on the northwest wall (ERDC-CERL, 2012).

There are cracks in most of the masonry walls. Most of them are minor and are a common wall crack probably caused by thermal or moisture expansion. However, two are of concern. One is a large crack that runs vertically along the northwest wall (Figure 153). The other crack is located above the second-floor chamber over the hall (Figure 151 and Figure 152). Both of these cracks have formed gaps in the exterior wall where one can see daylight through them, ultimately allowing the elements from outside into the building. Most cracks are attributed to the expansion of the wood framing on the interior, but the freeze-thaw cycle also contributes to the growth of cracks.

The CRM staff needs to immediately hire a professional brick mason knowledgeable in local brick structures. The mason should perform a thorough investigation of all brick in the Matthew Jones House to determine which bricks are too far gone and to determine the type of deterioration that is attacking the bricks (i.e., mechanical deterioration or chemical deterioration).

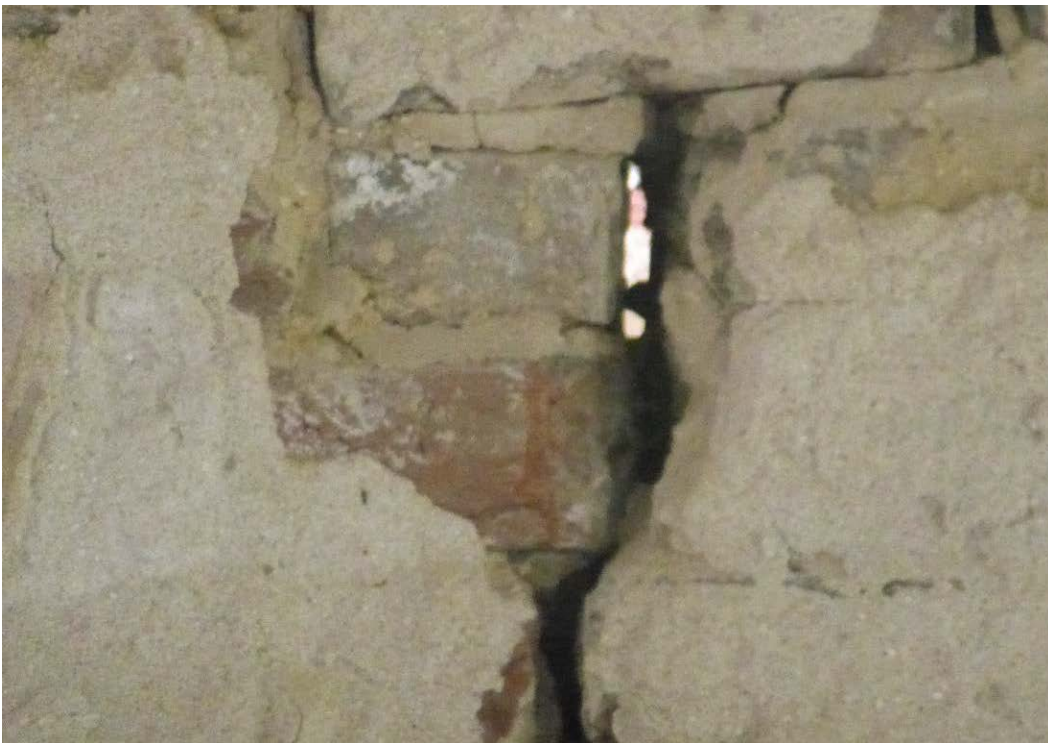
Figure 153. The knee-wall studs on the northwest wall caused vertical cracks not only in the plaster but also in the brick wall (ERDC-CERL, 2012).

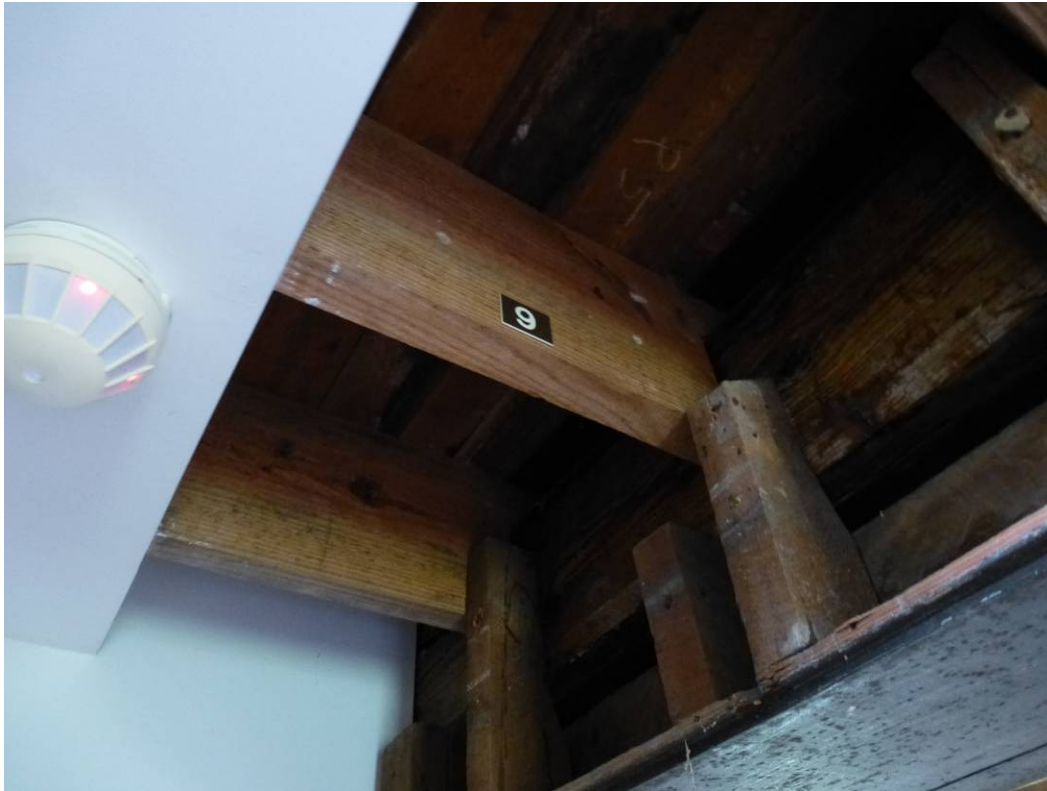
Figure 170. Most of the original ceiling joists in the main block of the house were replaced in Period III and then replaced in the preservation effort in 1993 due to decay (ERDC-CERL, 2012).

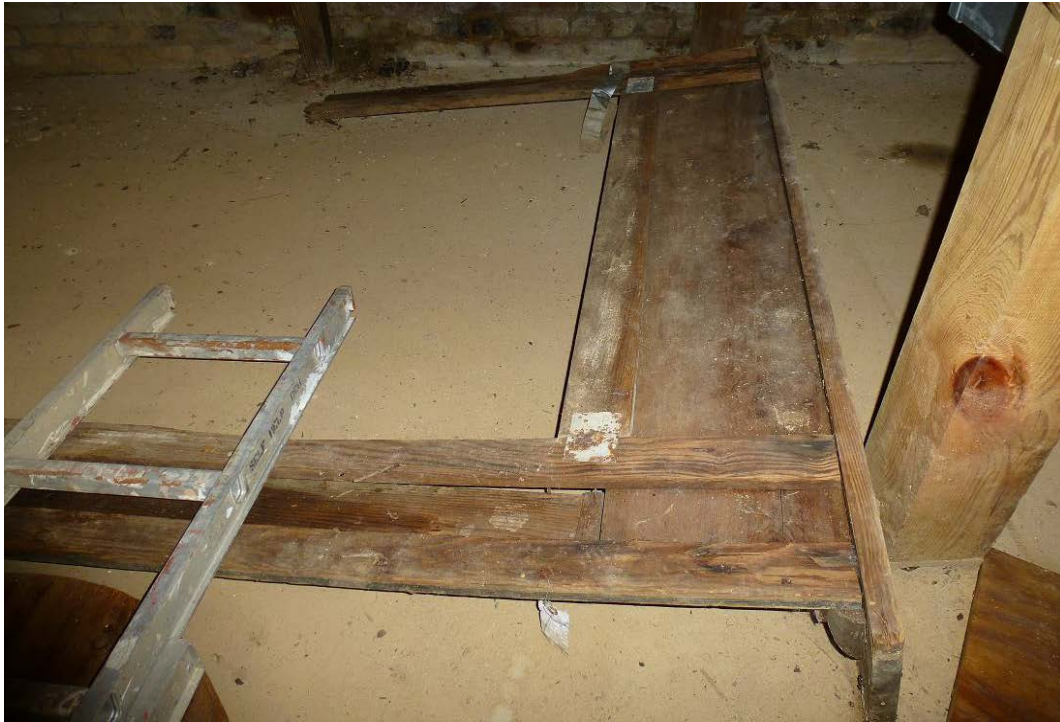
During field work for this report, it was noted that two of the wood mantels were being stored in the cellar. These two wood fireplace mantels are either stored on the cellar floor on which there is visible standing water (Figure 171) or propped against a damp cellar brick wall (Figure 172). These two architectural features need to be immediately removed from the basement and properly stored in a drier space.

Figure 171. One of the original 1893 wood mantels that has been removed from the fireplace surround is being improperly stored on the floor of the cellar (ERDC-CERL, 2012).

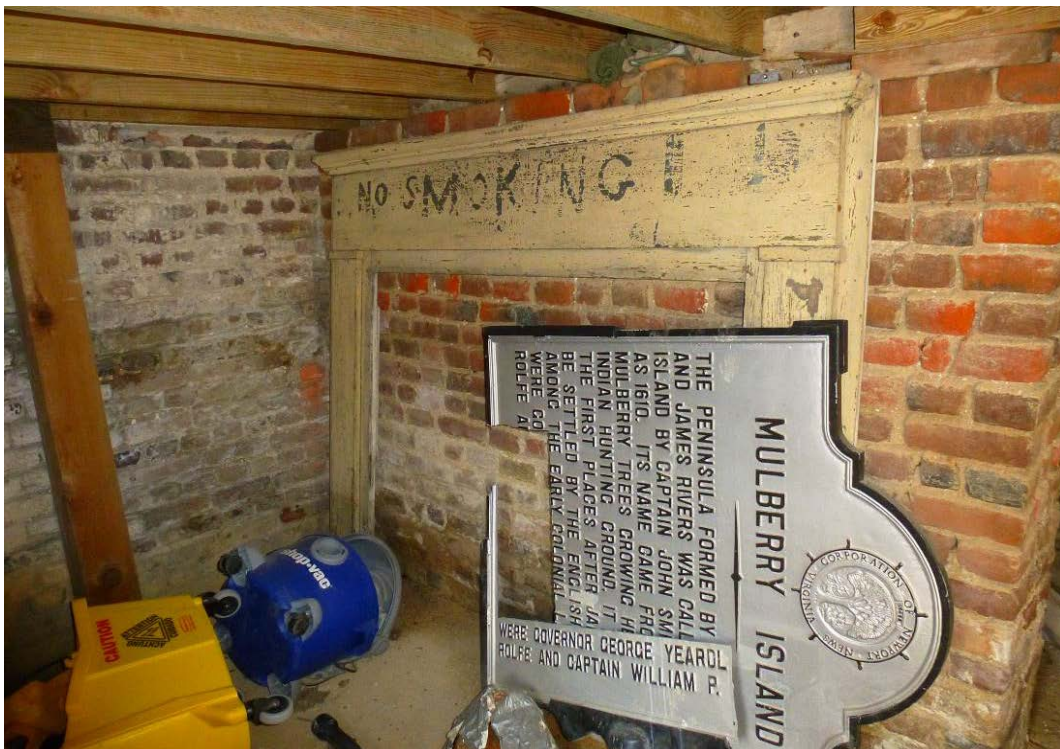
Figure 172. One of the original 1893 wood mantel (from first-floor hall) is being improperly stored when propped against a damp brick wall in the cellar (ERDC-CERL, 2012).

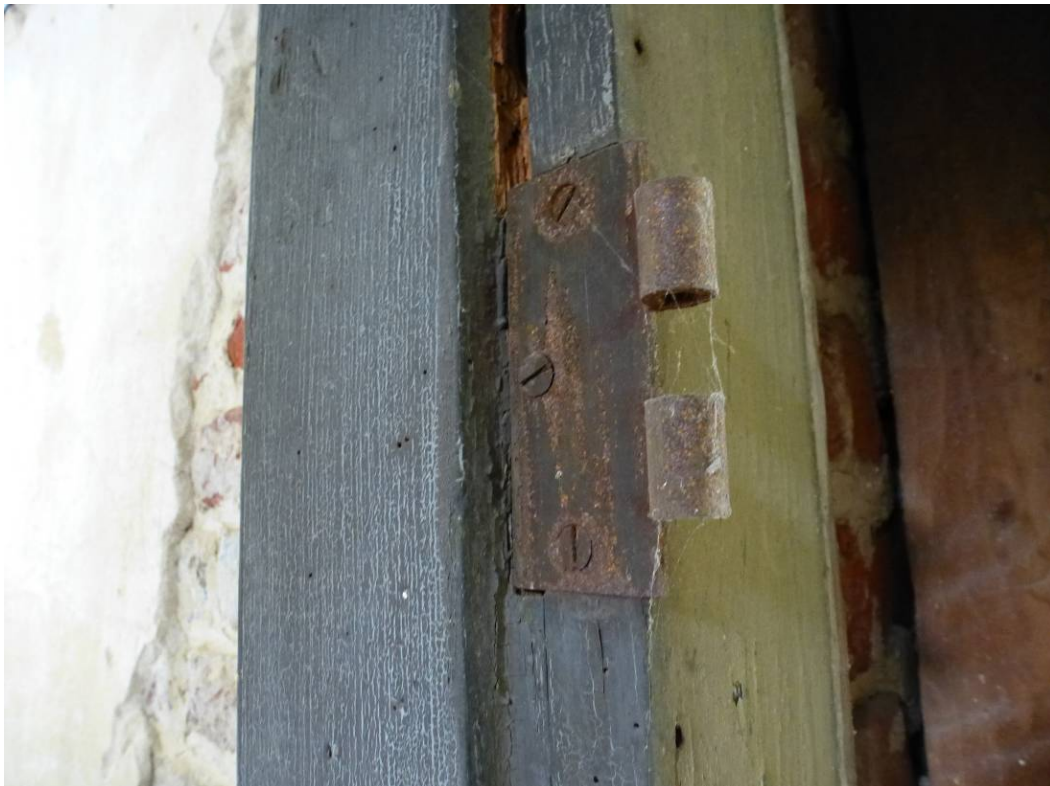
Figure 183. Rusty door hinge (ERDC-CERL, 2012).

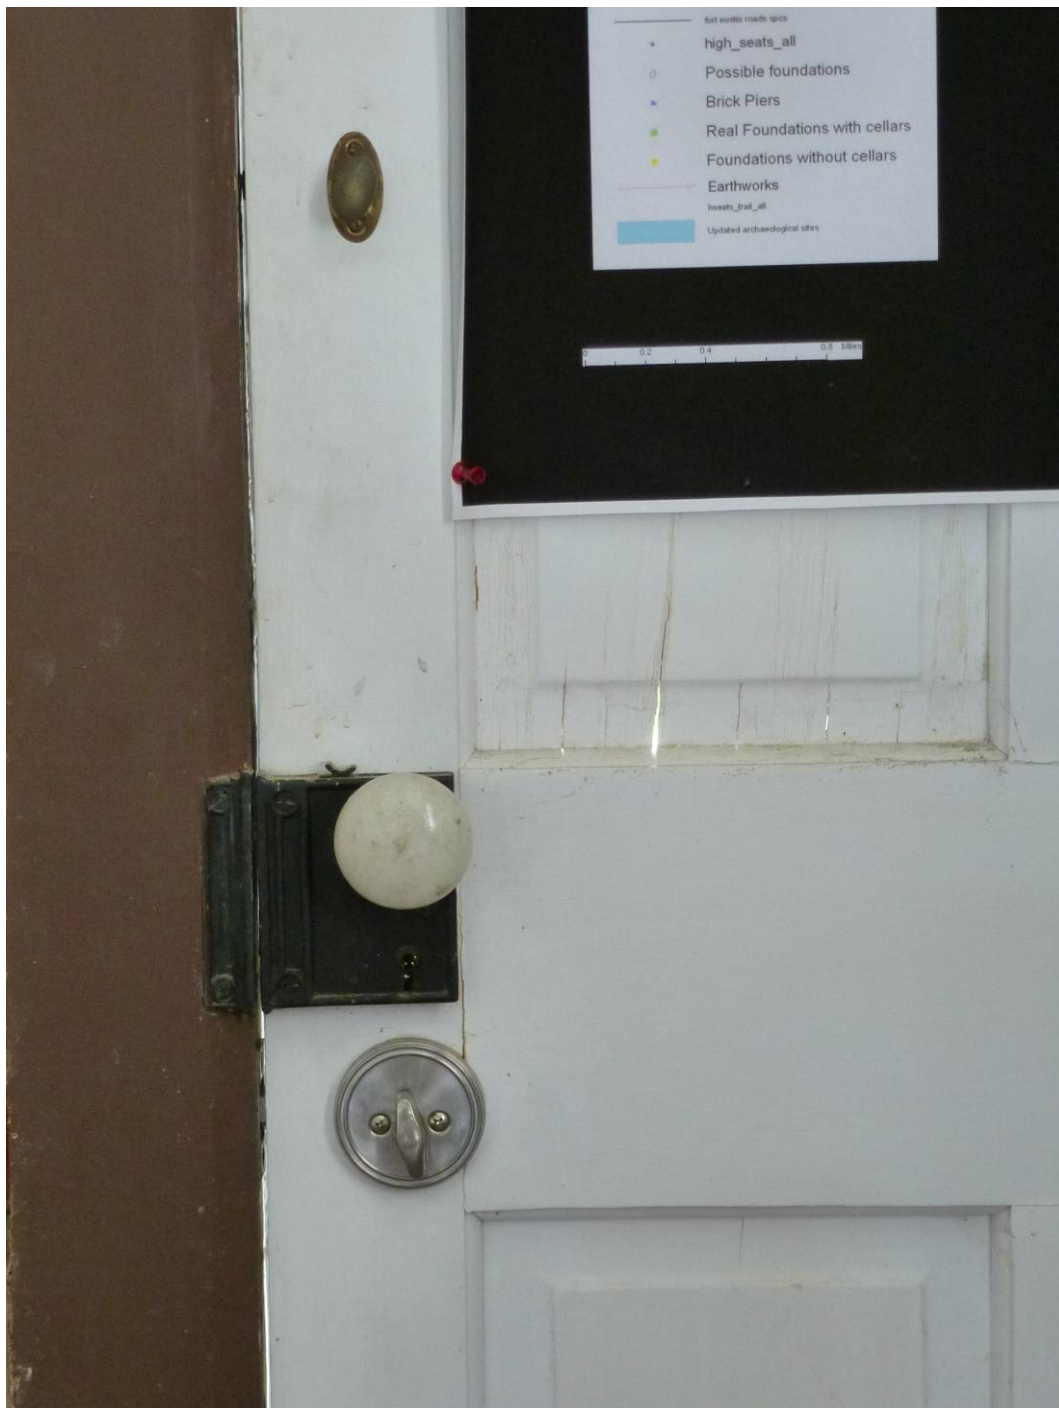
Figure 184. Original door hardware with newer deadbolt attachment (ERDC-CERL, 2012).
